ARMY AVIATION TEST BOARD FORT RUCKER ALA  
MILITARY POTENTIAL TEST OF NU-8F AIRPLANE. (U)  
OCT 64

FINAL  
REPORT OF  
MILITARY POTENTIAL TEST OF  
NU-8F AIRPLANE

DA PROJECT NO. 1X141809D179

USATECOM PROJECT NO. 4-4-1005-01

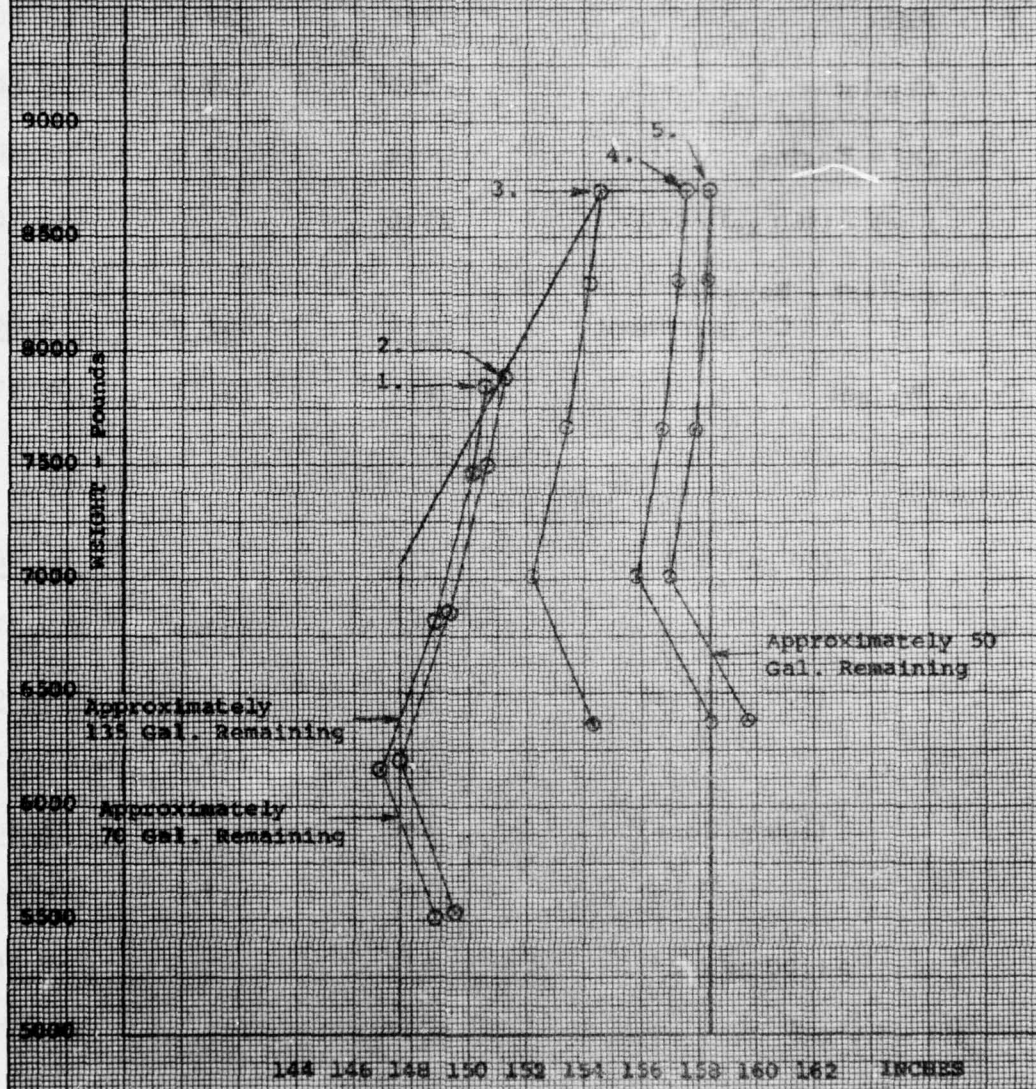
The center-of-gravity limitations posed no problem to loading for safe flight. However, under certain conditions, c.g. limits could be exceeded. (Figure 9.) Sample computations for normal mission profiles and corresponding graphs showing the movement of the center of gravity as fuel was consumed are shown in figures 4 through 9.

Although loading within the center-of-gravity (c.g.) limitations of the NU-8F posed no problem to safe flight, cognizance must be taken of the movement of c.g. as fuel is consumed to preclude exceeding c.g. limits. This is especially true with a rear c.g. at maximum gross weight loading, two pilots, no passengers and fuel fuel. Figure 9 shows that as fuel is expended, the c.g. moves forward at a rate less than the forward limit line until a point where the c.g. then moves rearward. The fuel system pumps fuel from the wing tanks (auxiliary) into the nacelle tanks (main tanks) and causes a forward c.g. movement. When the wing tanks are empty and fuel is consumed from the nacelle tanks, the c.g. then moves rearward.

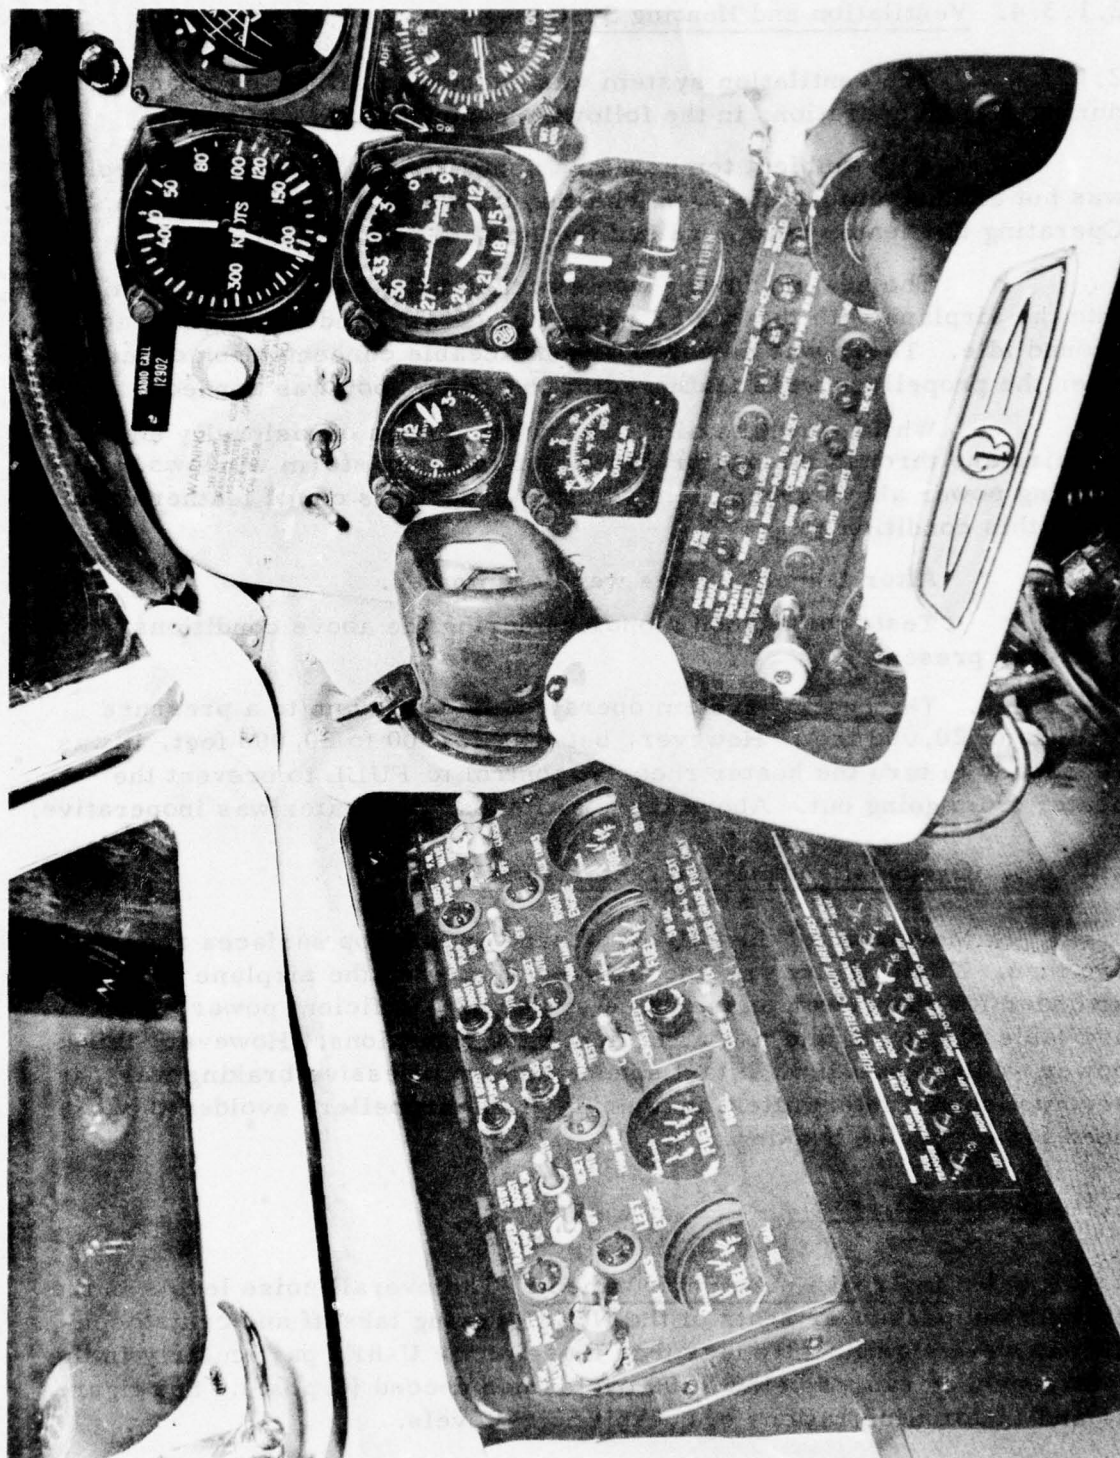
2.1.3.3.5. The fuel flow meter was found to be calibrated in pounds per hour while the fuel tank gauges were calibrated in gallons. This made rapid in-flight fuel endurance computations difficult.

Figure 10. NU-8F Fuel panel.

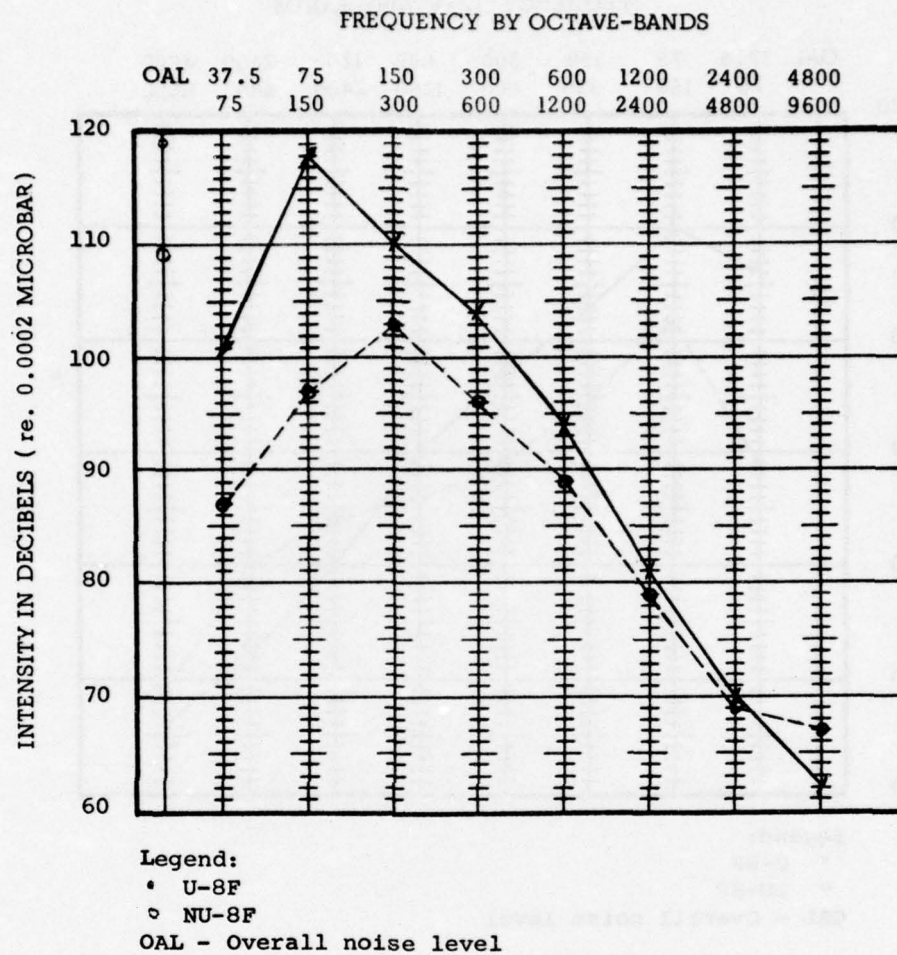
Figure 11

2.1.3.6.1. Internal Noise Environment. The overall noise levels in the cockpit and passenger seats of the NU-8F during takeoff and cruise conditions were significantly less than those of the U-8F, particularly in the low frequency ranges below 1200 cycles per second (c.p.s.). See figures 11 and 12 for illustrations of cockpit noise levels.

2.1.4.7.1. Internal Noise Environment. The overall internal noise levels of the NU-8F during takeoff and cruise conditions were significantly lower than those of the U-8F, particularly in the low-frequency ranges below 1200 c.p.s. This is especially important because Army standard headsets and APH-5 ear muffs offer greater protection against high frequency noise components. The overall levels still exceed the 90 decibels (db) criteria established by the Surgeon General, US Army, to facilitate speech communication and prevent temporary hearing loss for non-protected ears.

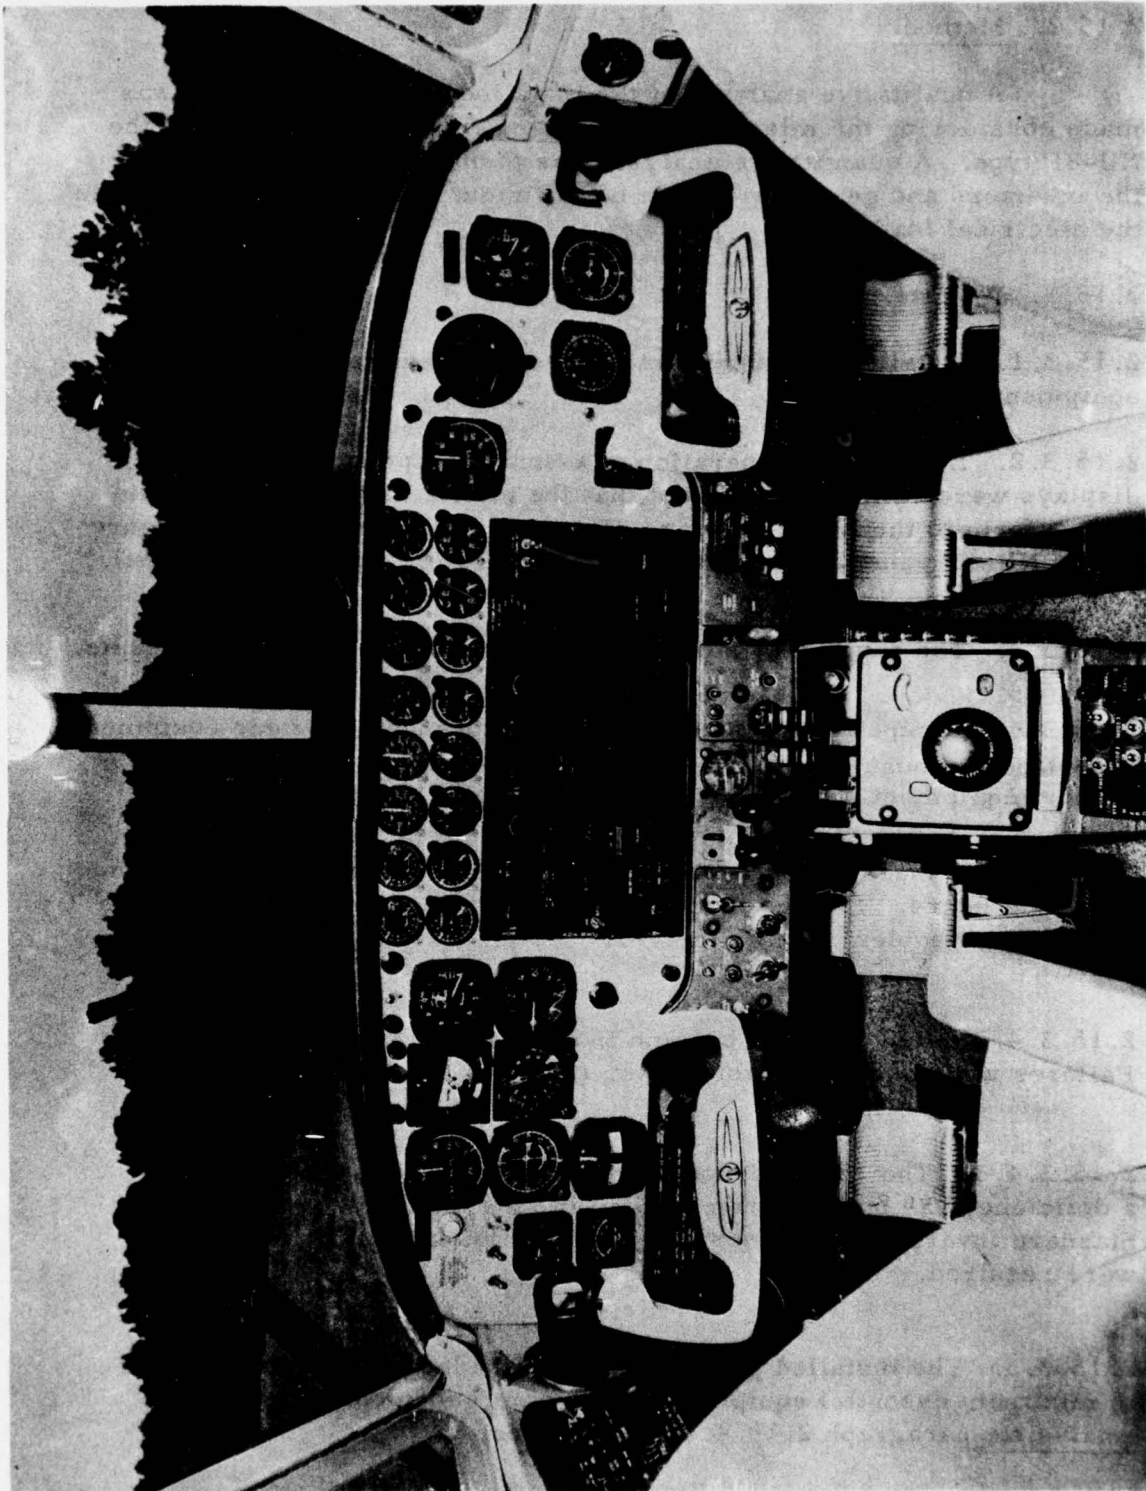
Figure 32. NU-8F cockpit and panel arrangement.

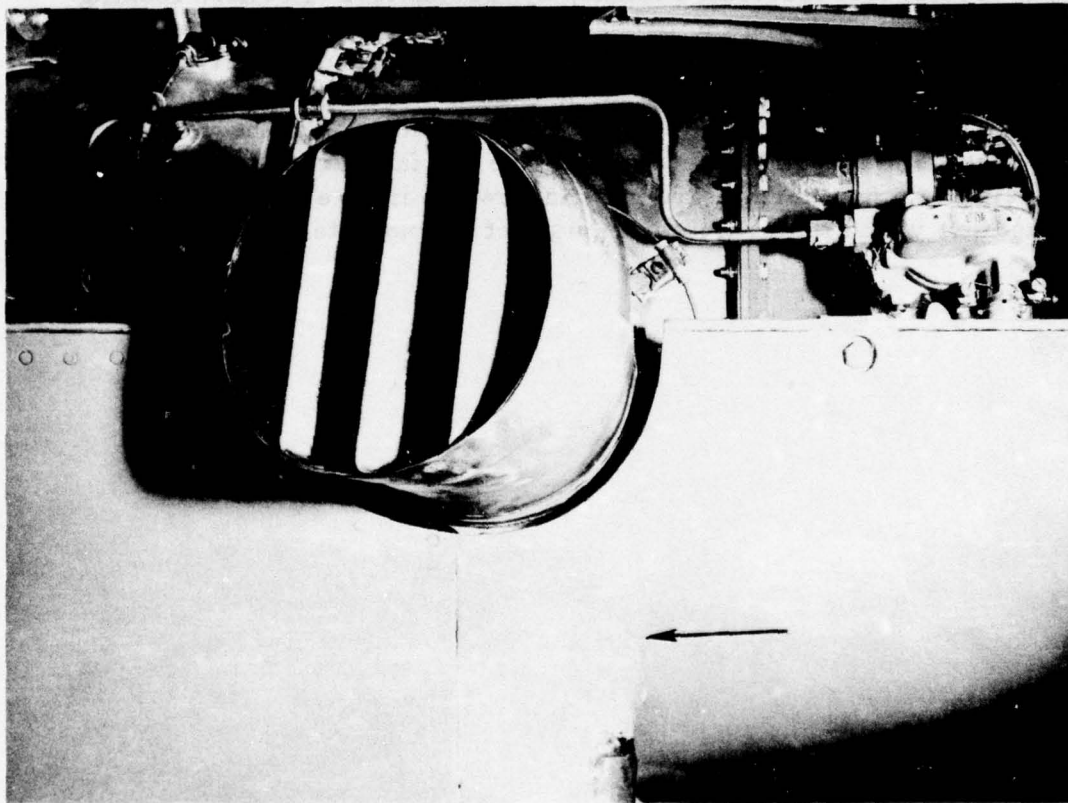
Figure 36. Engine cowl with cracks at engine scoop.
